# INTEGRATED BIO-GEOMORPHOLOGY INVESTIGATION YEADING BROOK WEST IN HARROW

# Angela Gurnell<sup>1,2</sup> and Daniel Perkins <sup>3,4</sup>

We report on the outcomes of a combined biological and physical habitat investigation of sites along the Yeading Brook West within Harrow. The following are key factors that influenced the work undertaken:

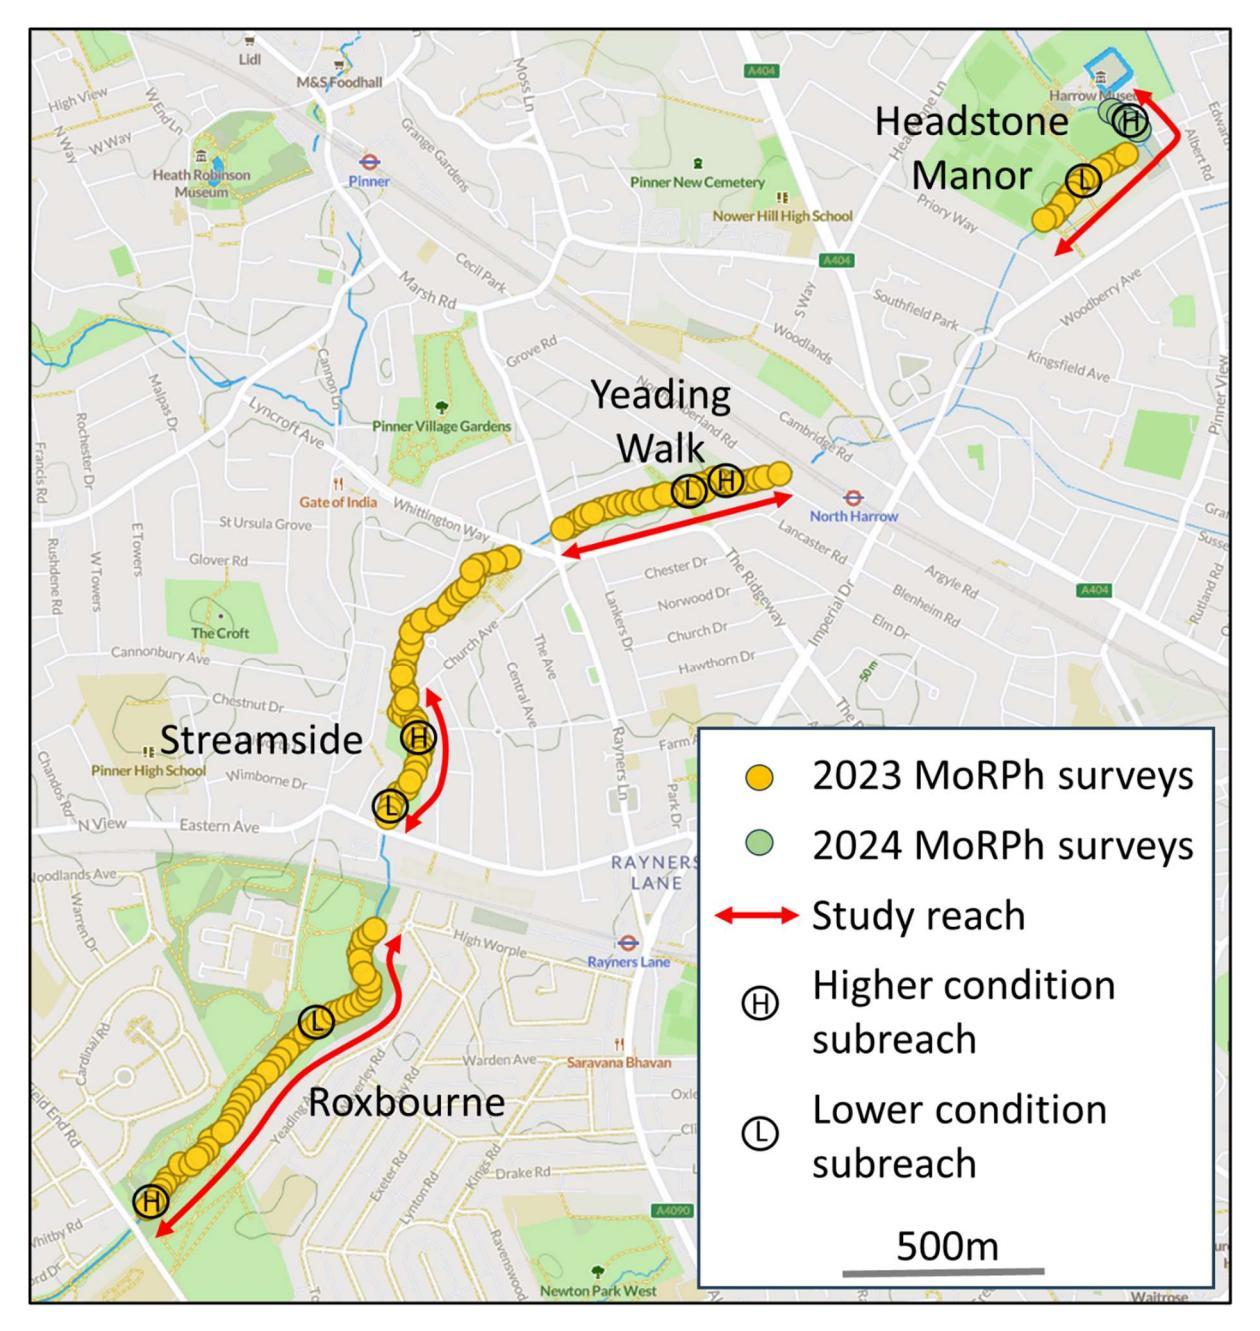
Figure 1: The four reaches (from Headstone Manor (upstream) to Roxbourne (downstream)) considered in this investigation in relation to the 142 20m long MoRPh surveys conducted in 2023.

The red lines shown on Figure 1, delimit the four reaches of Upper Yeading Brook West that were the focus of the present pre-restoration study. Throughout this report, we will refer to these red-line reaches as Headstone Manor, Yeading Walk, Streamside and Roxbourne. At Headstone Manor, the red line (Figure 1) extends northwards beyond the 2023 MoRPh surveys. During June 2024, we conducted additional MoRPh surveys in this upstream part of the reach (Figure 1) to give complete MoRPh survey coverage (a total of 120 MoRPh surveys) of the four reaches.

We inspected each of the 8 MoRPh5 subreaches in the field to identify a representative site for sampling. Each site was defined by two MoRPh surveys (i.e. a 40 m subreach length). The eight sampling sites are referred to by their reach name (Headstone Manor, Yeading Walk, Streamside, Roxbourne) followed by H or L depending upon whether they are located within the higher (H) or lower (L) scoring MoRPh5 subreach (the H and L sampling sites are indicated in Figure 1).

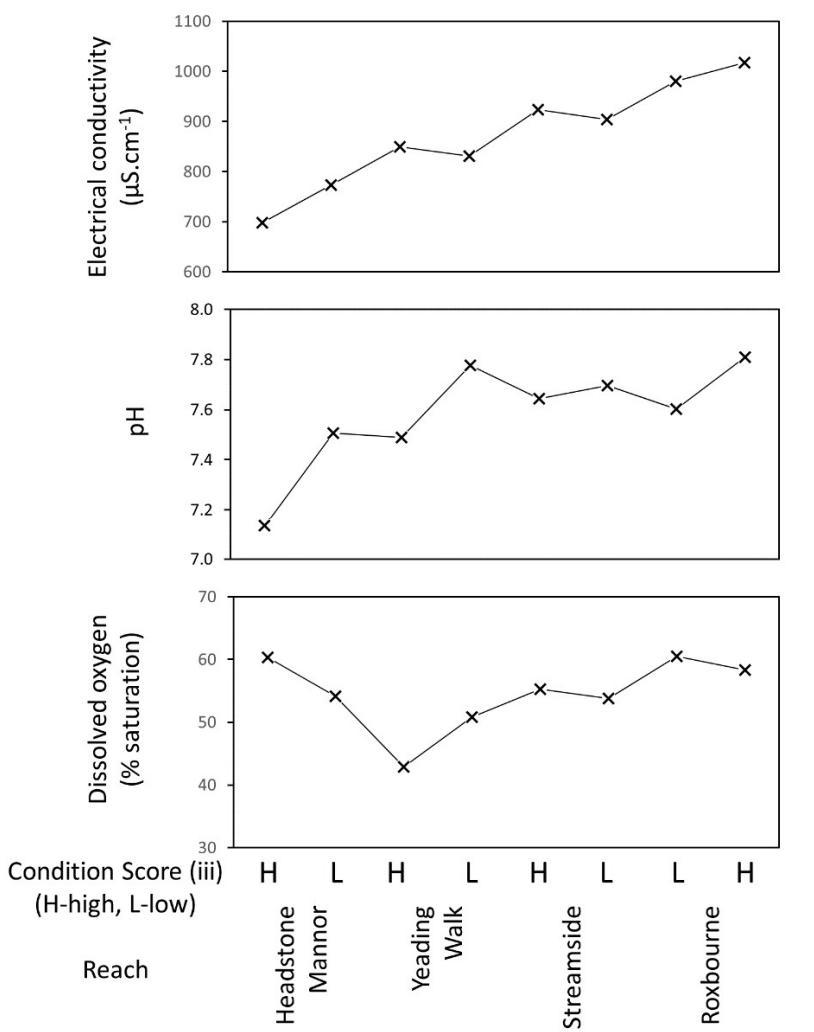
Figure 2: Electrical conductivity, pH and dissolved oxygen (average of three readings) observed at 8 sampling sites during 4<sup>th</sup> June 2024. (Note: each subreach is labelled L or H to indicate whether it had a relatively high (H) or low (L) value on **Condition Score** (iii))

Table 2 lists the three observations of electrical conductivity, pH and dissolved oxygen that were obtained from each sampling site. Figure 2 shows the average values of these measures for each site, revealing a downstream increase in electrical conductivity and pH (increasingly alkaline) and an initial fall in dissolved oxygen to Yeading Walk followed by a rise.

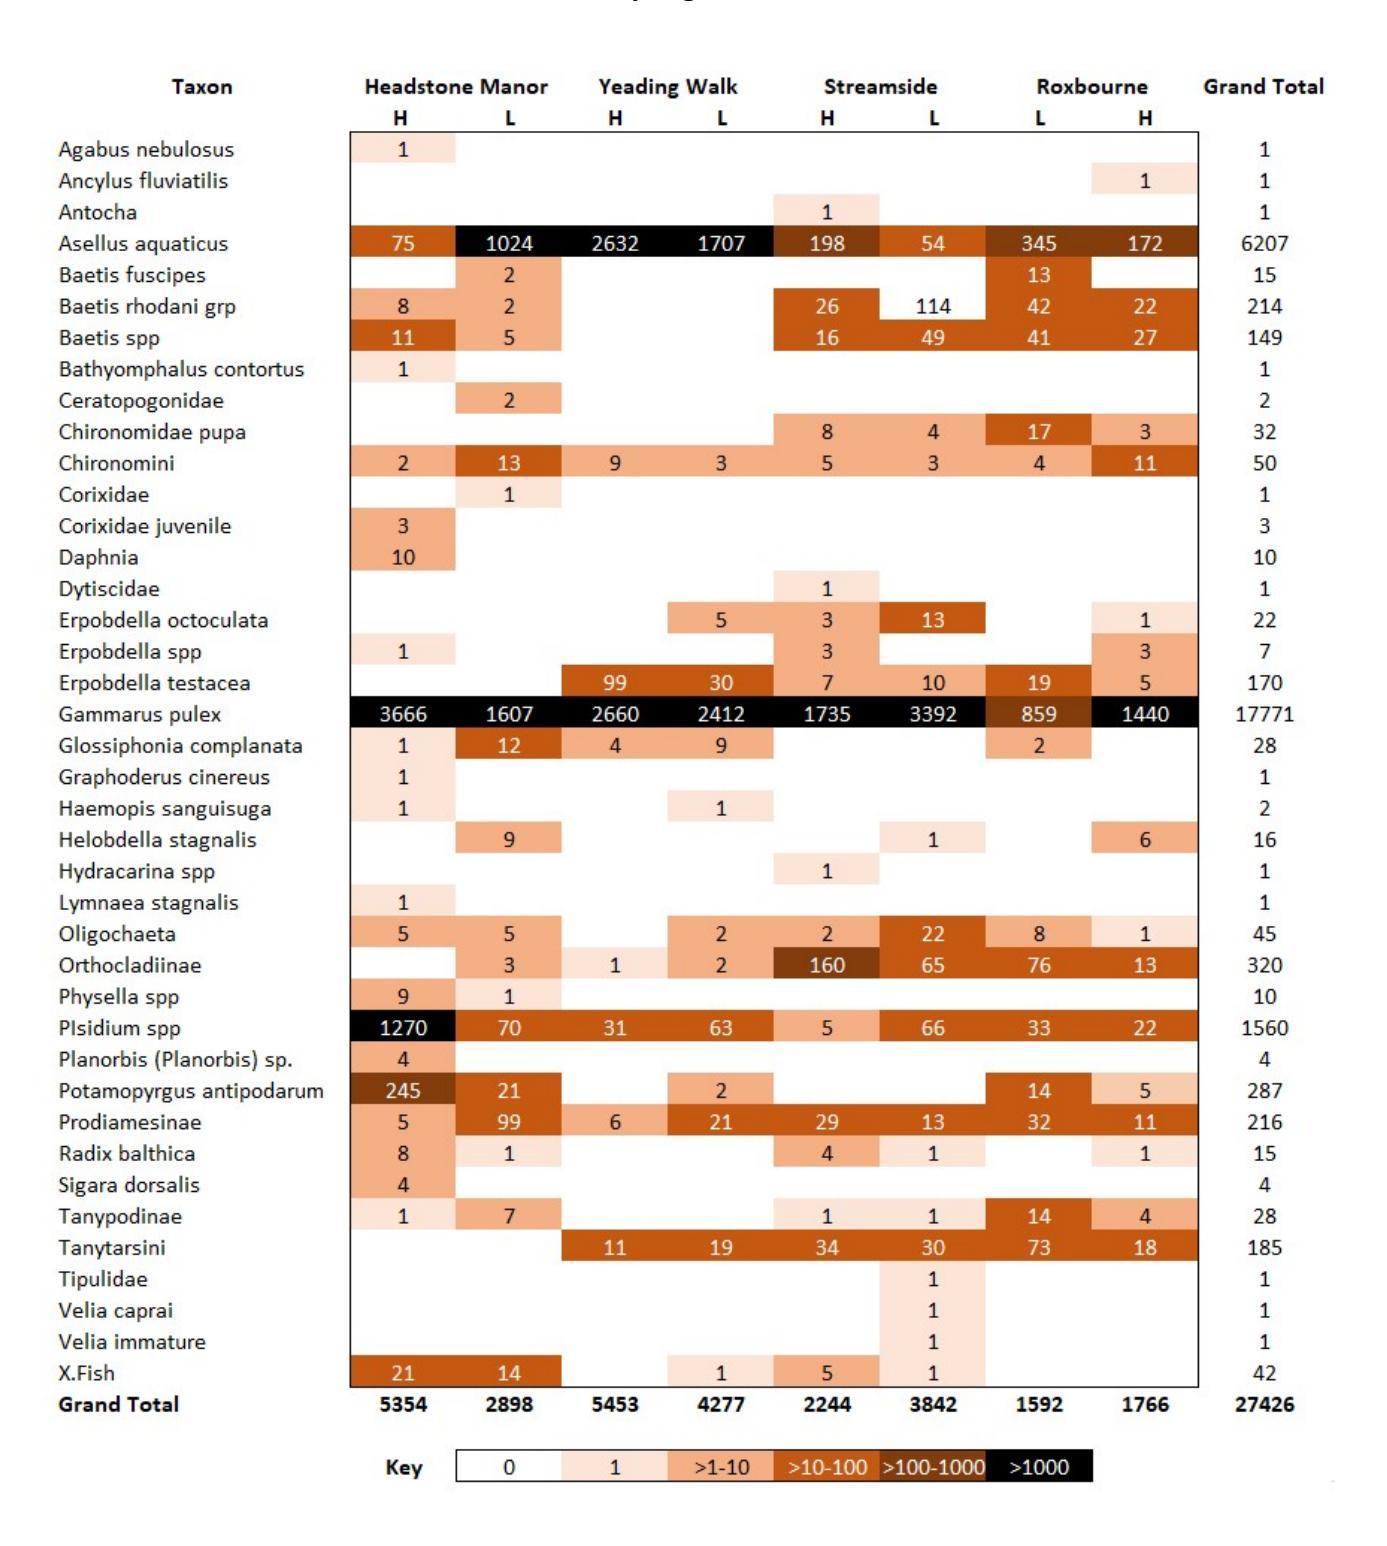
Table 4: The number of individuals in each taxon identified in the samples collected from the eight subreaches (subreaches are arranged from upstream (left) to downstream (right)). Note: fish (X.fish) and waterfleas (Daphnia) were excluded from taxon richness estimates (Table 3) since these groups are underrepresented using benthic kicknet sampling.

Over 27000 individuals from 39 taxa were identified in the eight macroinvertebrate samples. Table 3 summarises these across the sampling sites. Table 4 breaks the data down by taxon as well as sampling site and uses colour shading to highlight broad differences in the number of individuals observed by taxon and sampling site.

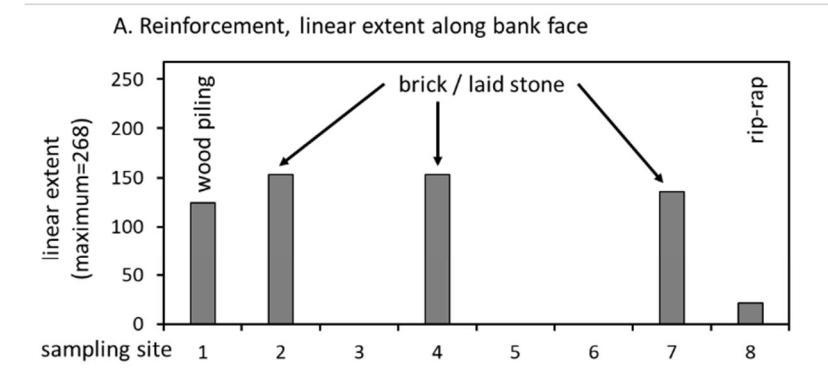
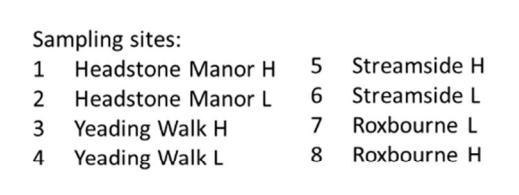
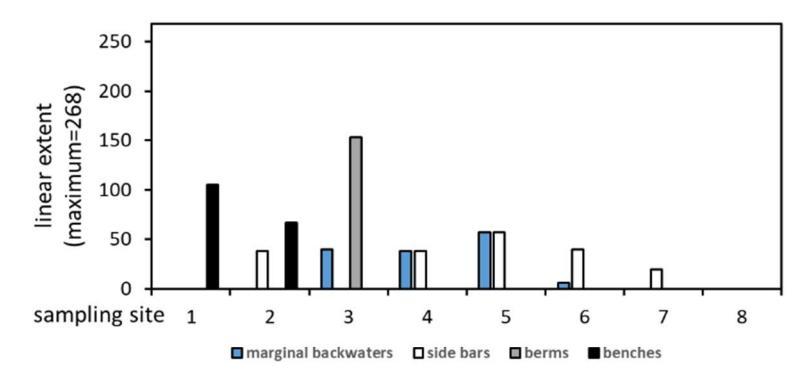
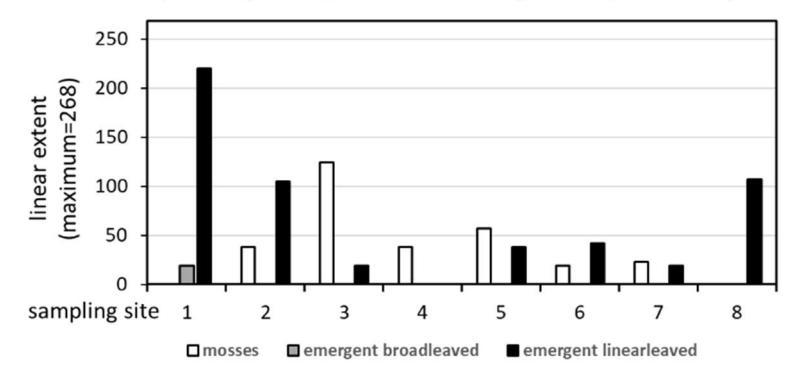
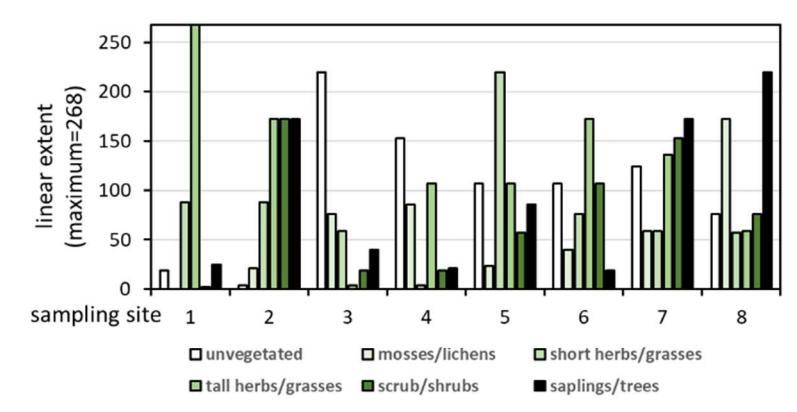
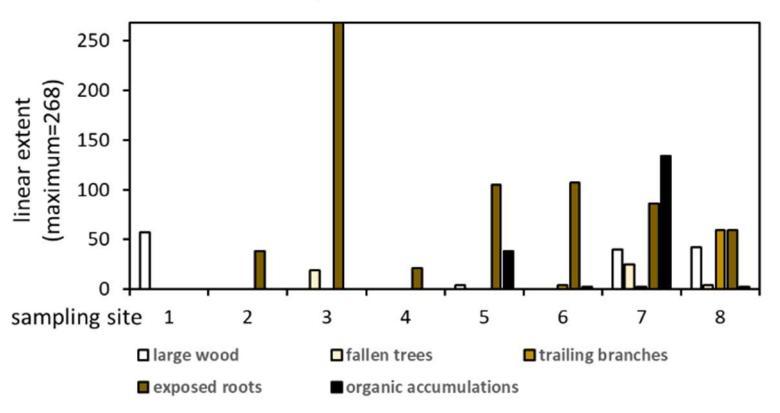
B. Marginal physical features, linear extent along channel/water margin

Figure 3 (preceding page): Changes in the extent of selected features along bank faces and channel/ water margin between sampling sites. A. reinforcement (dominant type); B. physical features (backwaters, bars, berms, benches); C. aquatic vegetation (mosses, emergent broadleaved, emergent linear-leaved); D. terrestrial vegetation (bare, mosses/lichens, short herbs/grasses, tall herbs/grasses, scrub/shrubs, saplings/trees); E. tree-related features (large wood, fallen trees, branches trailing into channel, exposed roots, discrete organic accums.).

Figures 3 and 4 illustrate how some of these whole channel numerical indicators and presence/abundance vary across the sampling sites along the bank faces and channel/water margin (Figure 3) and on the bed (Figure 4). The graphs presented in Figures 3 and 4 have a vertical axis extending from zero to the maximum achievable value.

Human interventions at the sampling sites are mainly confined to bank and bed reinforcement (Figure 3A, 4B), although there were a small number of pipes/outfalls at the two Roxbourne sampling sites. The horizontal extent of bank reinforcement (Figure 3A) was quite extensive at the two Headstone Manor sites, Yeading Brook L and Roxbourne L. The reinforcement was comprised of brick/ laid stone (including laid concrete-filled bags) in most cases. While most of the reinforcement was confined to the bank toe, it extended across the entire bank face at Headstone Manor L. Bed reinforcement mainly took the form of bricks, boulders and concrete blocks that had probably originated as part of bank reinforcement measures that had been washed out and deposited across the bed. Significant quantities were present at Roxbourne L, with smaller quantities observed at Headstone L, Yeading Walk H and L, Streamside H, and Roxbourne H. Some of this reinforcement material has become rounded by river flows, accounting for the bouldersized 'particles' observed on the bed of these same sampling sites (Figure 4A). Boulder size particles are not naturally present in the Brook.

Many different physical features were observed, some of which are illustrated in Figures 3B, 3E and 4D. Pools and riffles (Figure 4D) were present at expected levels for this stream type apart from at Yeading Walk L and H, where riffles were absent. Channel/water margin features were few and of low abundance (Figure 3B). The deep and narrow channels present at most of the sampling sites probably restrict the development of these water-edge features. Tree-related features on the channel bed (not illustrated) were rare apart from tree roots extending across the bed at Yeading Walk H and Streamside L. However, there were a variety of tree-related physical features (habitats) along the bank face (Figure 3E), which were particularly diverse and abundant at Roxbourne H and L.

Terrestrial vegetation on the bank face was structurally complex at all sampling sites (Figure 3D), but there were notable differences between sites in terms of the relative importance of tree/sapling/shrub/scrub cover when compared with mosses/lichens/herbs/grasses. The former showed the highest abundance at Headstone Manor L, Streamside H and L and Roxbourne H and L. Aquatic vegetation was largely confined to the channel/water margin across all sampling sites, where it was dominated by emergent linear-leaved plants and mosses (Figure 3C). In general, the linear extent of aquatic plants along the river banks was small, with the exception of Headstone H.

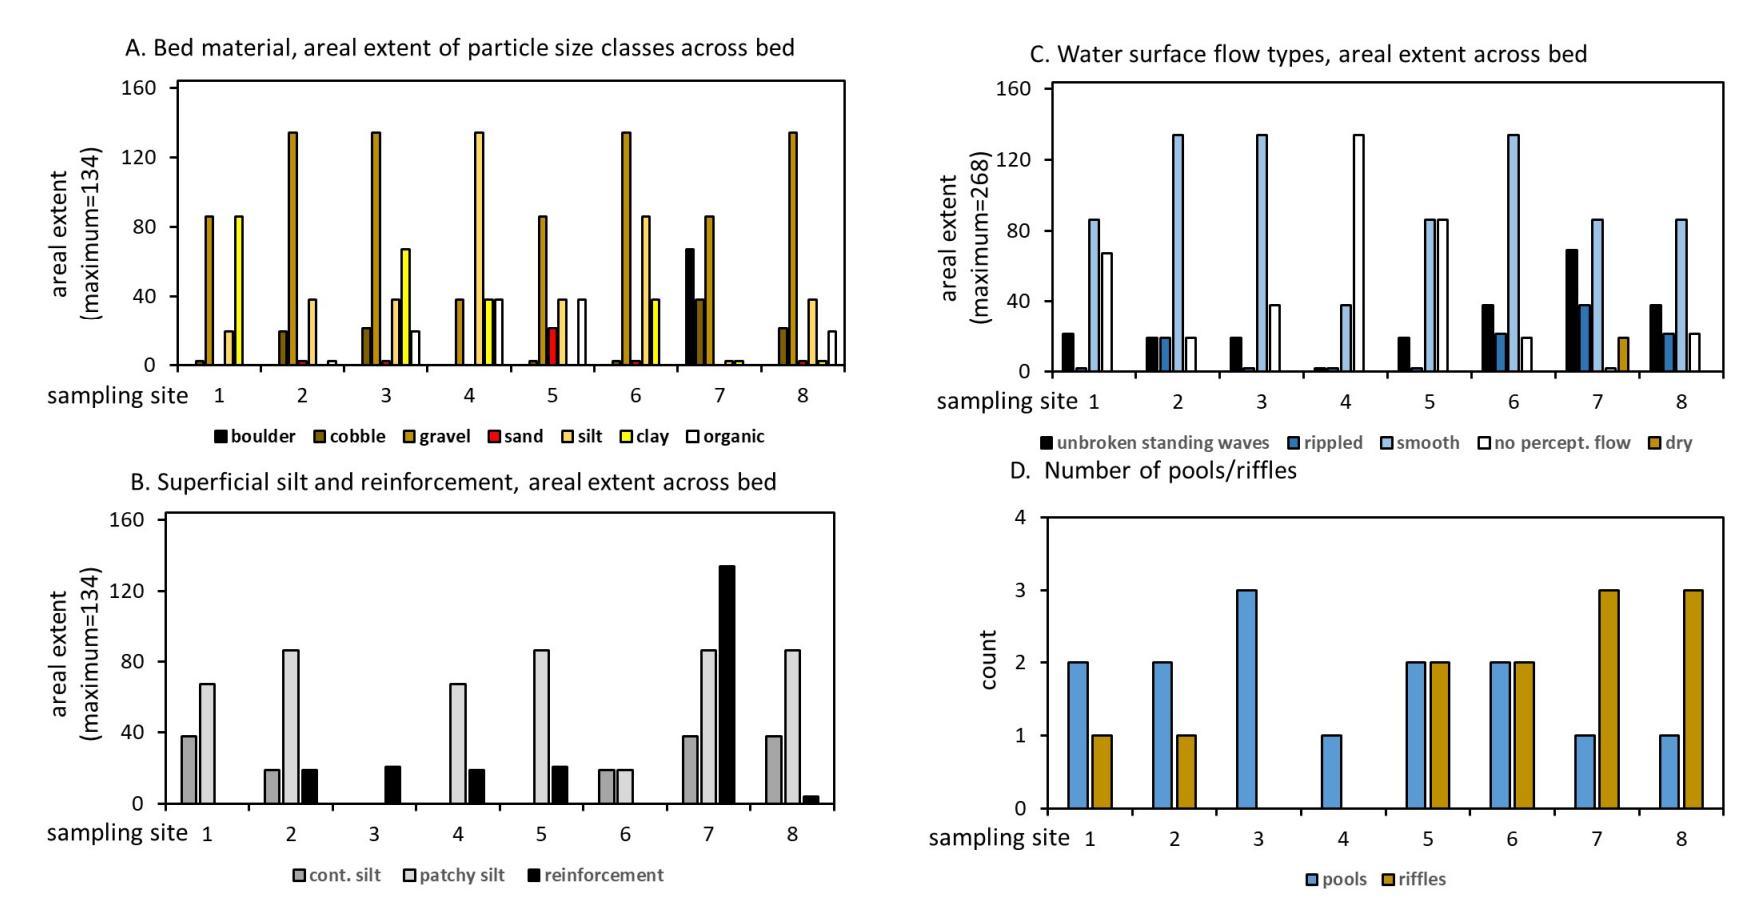
Figure 4: Changes in the extent of selected features across the bed between sampling sites. A. bed material particle size classes; B. superficial silt and artificial reinforcement; C. flow types; D. number of pools and riffles. (For key to sampling site names see Figure 3

Water flows interact with sediments to build physical habitats, so it is important to see these not only as physical (hydraulic, sediment) habitats but also as drivers of the other physical features that are present. Although relative abundances varied, all sampling sites displayed at least four flow types (hydraulic habitats): unbroken standing waves, ripples, smooth and no perceptible flow, with a 'dry' exposed area of the bed also present at Roxbourne L (Figure 4C). These are all flow types associated with medium to low flow velocities, but the flow types and velocities would change if observations were made during higher flow conditions. All sampling sites also displayed patches of at least four sediment particle size classes of bed material (Figure 4A), indicative of a diverse alluvial bed. The particle size classes and their relative abundnaces varied between sampling sites. Bed siltation is present at some sampling sites (Figure 4B). Siltation can smother gravelcobble bed surfaces and is usually indicative of local silt penetration into the bed. This may adversely affect macroinvertebrate communities (surface and subsurface habitats) and fish (siltation of spawning beds) but fortunately the areal extent of siltation was modest at most sampling sites, with Headstone Manor L and H and Roxbourne L and H showing the greatest areas of superficial silts.

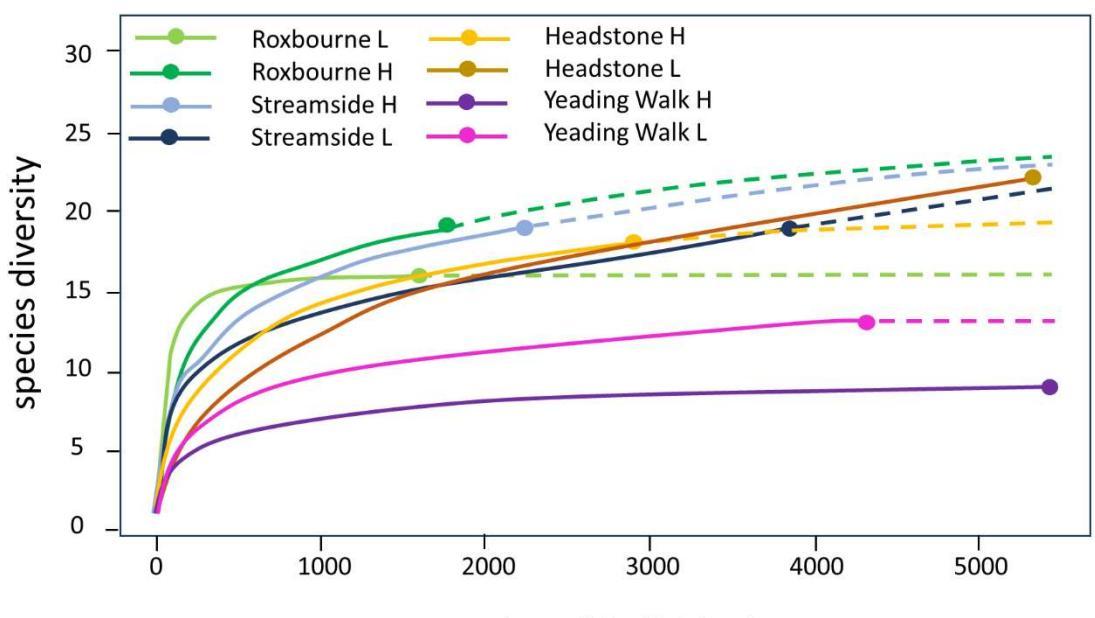
Figure A:. Macroinvertebrate taxon richness rarefaction (solid line segment) and extrapolation (dotted line segments) sampling curves between subreaches. Dots represent the reference samples.

Table 3: The number of individuals and taxa identified (and estimated) in the kick samples collected in the eight subreaches (subreaches are arranged from upstream (top) to downstream (bottom)). The number of estimated taxa (and 95% confidence intervals) are derived for a common sample size (the maximum number of individuals observed in a single sample: 5453 individuals) using species-accumulation simulations (Appendix Figure
